An assessment of microplastics in two freshwater ecosystems in
Gauteng

Dissertation submitted in fulfilment of the requirements for the degree

In Zoology

OCTOBER 2020

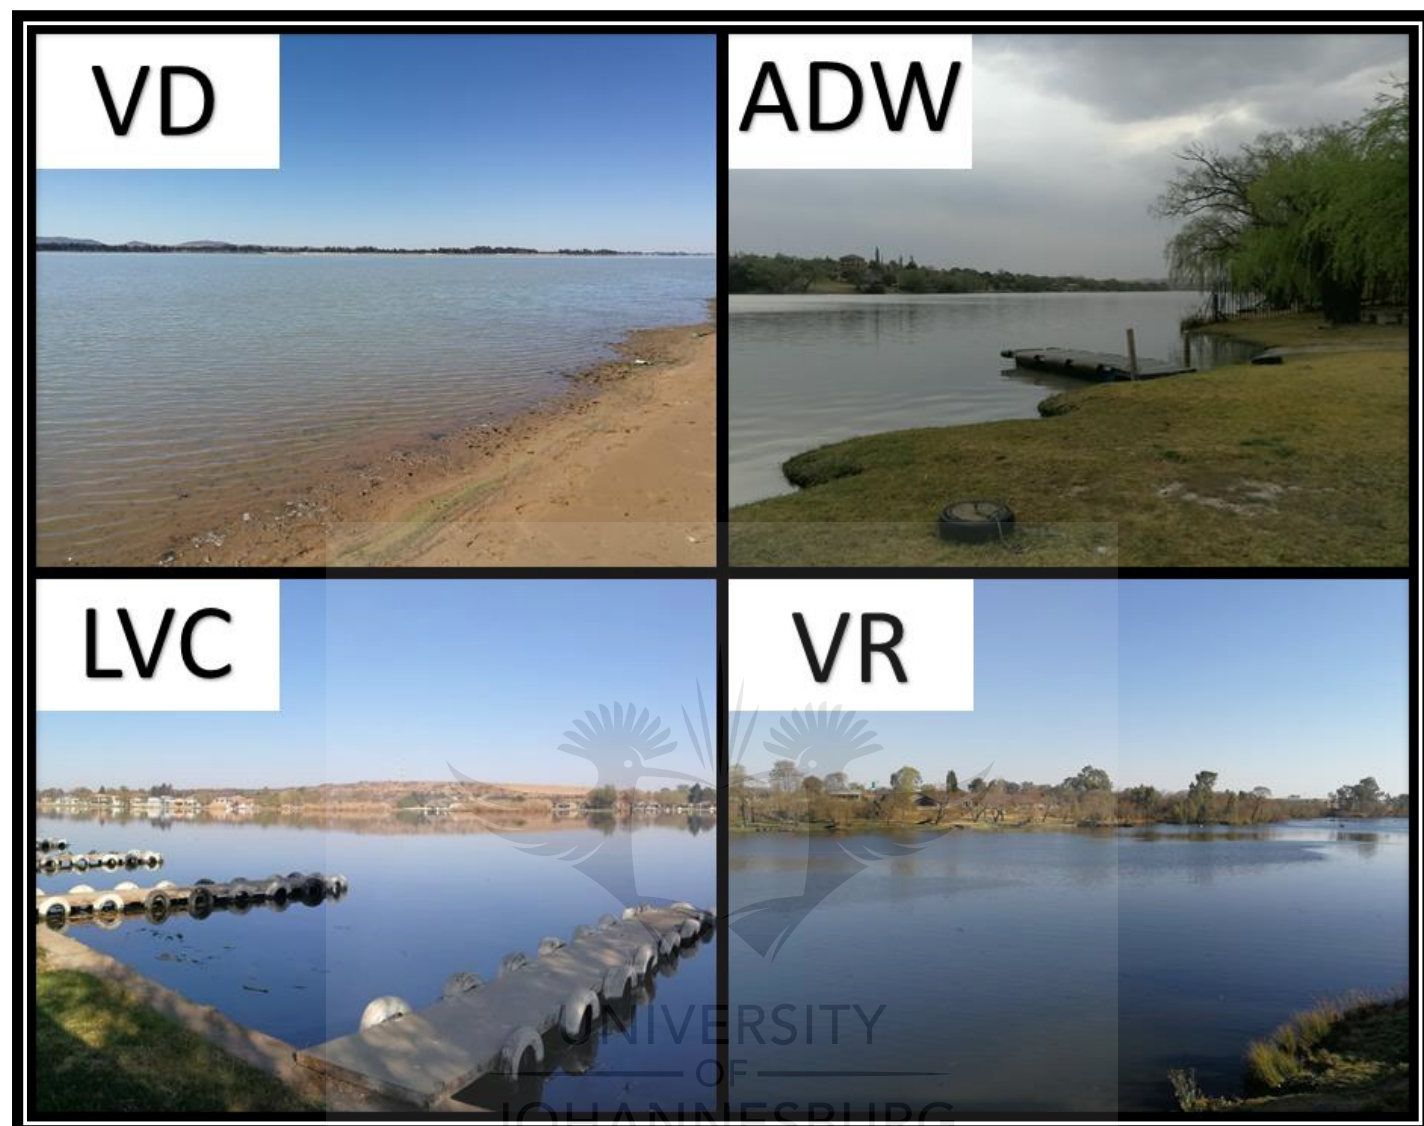
Figure 3: Photos of the upper Vaal River where sampling took place. Sampling points follow downstream from Vaal Dam (VD) to After Dam Wall (ADW), Loch Vaal Club (LVC) and Vaal Rus (VR), the site furthest downstream. VD represents the Vaal Dam and LVC the Vaal River Barrage. ADW is located after the Vaal Dam wall and VR follows after the Vaal River Barrage.

After Dam Wall (ADW) was located approximately 1.5 km downstream of the Vaal Dam wall. The stretch of the river where sampling took place appeared to have some human impact with residential houses on the eastern bank. The water was teeming with life in the forms of aquatic invertebrates that were observed in the water. The section of the river was extremely deep, being >2 m in depth just over a meter from the shore. Microplastic levels were expected to be increased in water and decreased

Vaal Rus (VR), was located approximately 4.7 km downstream of the Vaal River Barrage. The weather over the two days of sampling remained constant with no extreme weather patterns. The water was incredibly polluted with algae and other indications of possible sewage runoff. The shoreline depth was similar to that of VD. Here microplastic loads were expected to increase as it was presumed the most polluted section of the river, however, sections of the river that consisted of massive stones and boulders may influence sediment microplastic loads.

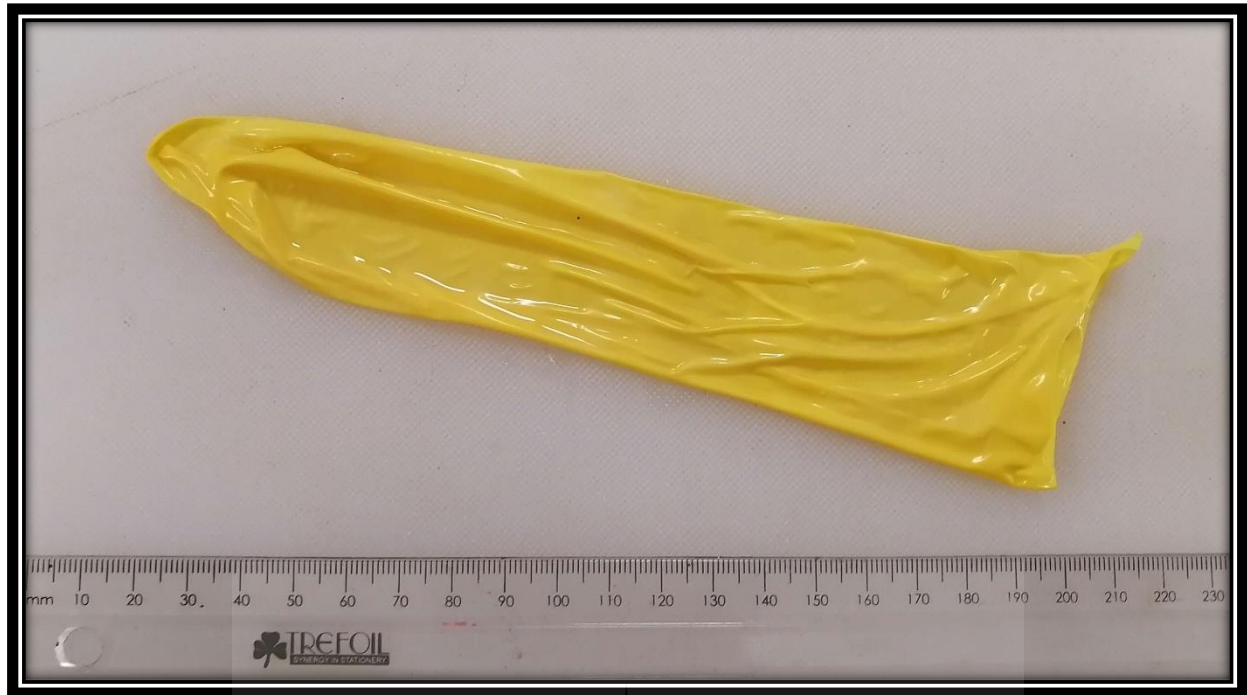
Figure 19: Photo of a degraded condom (possible macroplastic) collected in the gastrointestinal tract of a fish collected in this study at ADW.
